September 20, 2024

RE: Idaho Falls High School Ceiling Evaluation

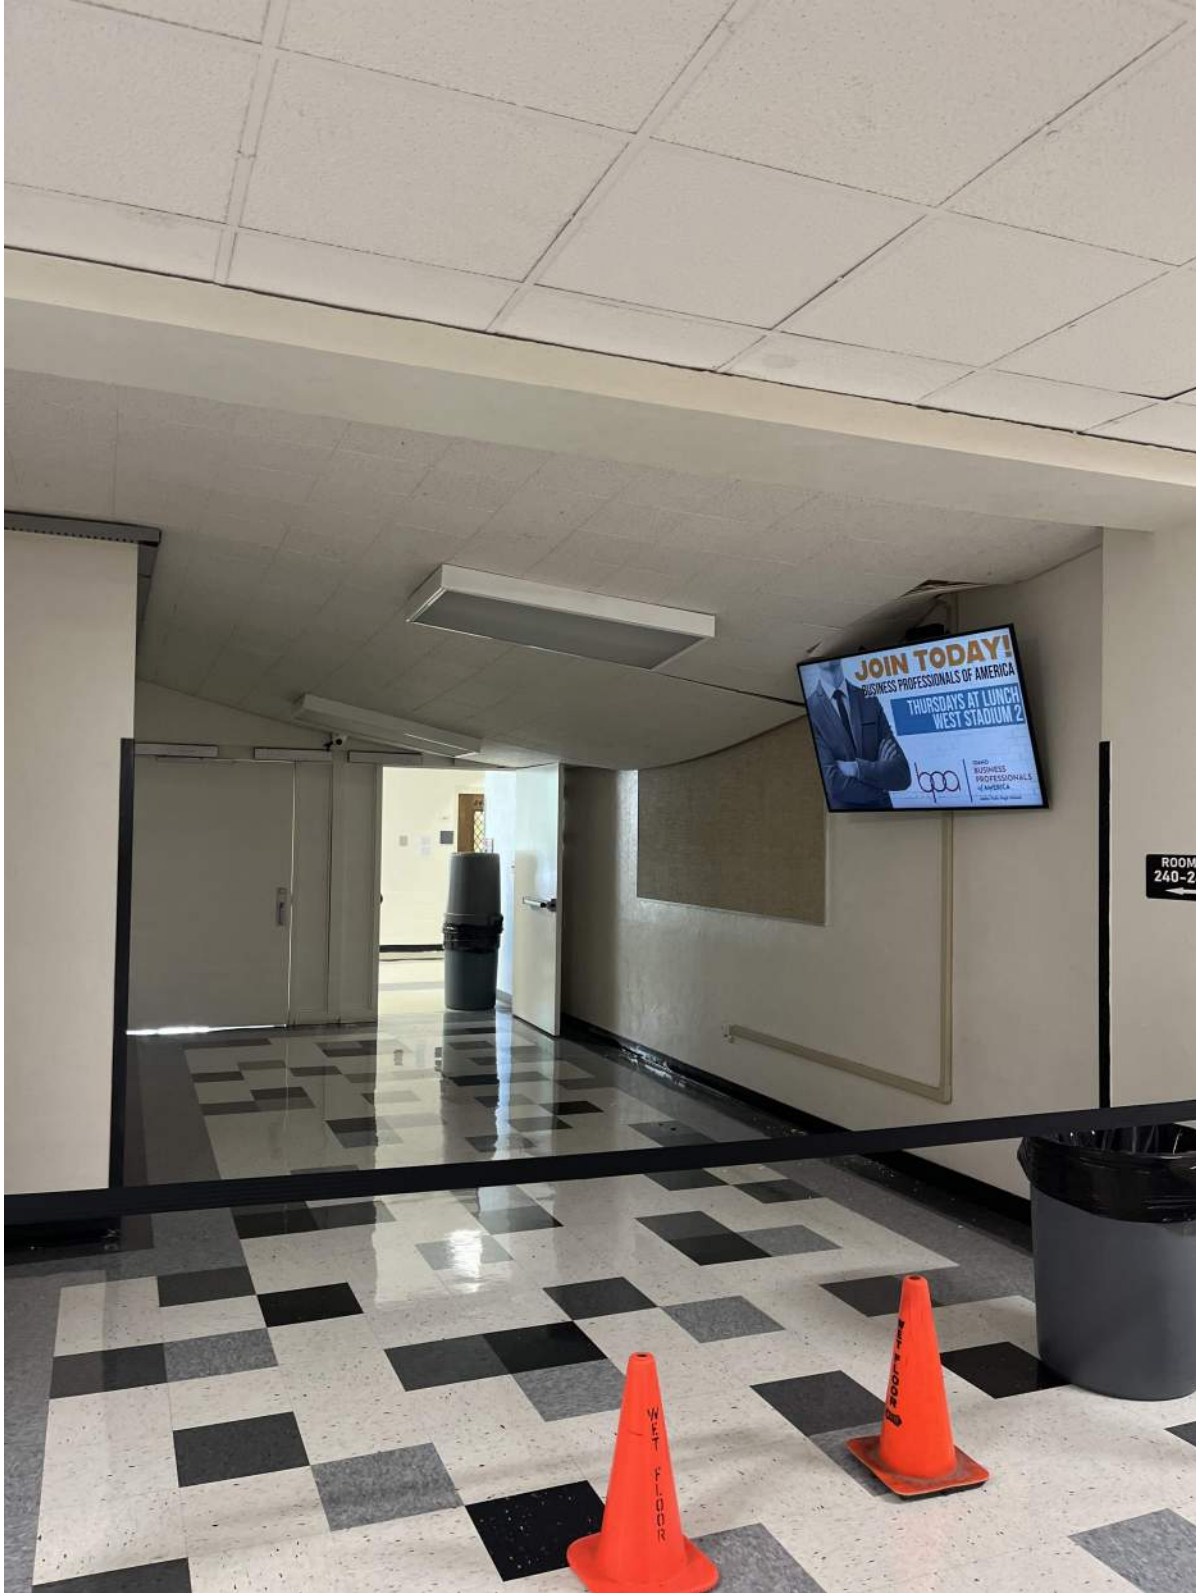
On September 4th, 2024, Kore 4 visited Idaho Falls High School located at 601 S Holmes Ave, Idaho Falls, ID 83401 to assess the structural condition of the suspended ceiling. Over Labor Day weekend, a portion of suspended ceiling collapsed in the hallway on the second floor, see photos #1 and #2. This portion of suspended ceiling was installed during an addition in 1991. This raised concern about the remaining suspended ceiling that was installed during the same time frame.

In our engineering judgment, we believe the collapse of the suspended ceiling was due to being insufficiently installed at the time of construction. With the wires holding it only being stapled, any form of disturbance could have caused the wire ties to slip through the staples, or even the staples to have pulled out of the supports entirely. We also believe that a contributing factor to the collapse was the presumption that people were using the suspended ceiling to support their entire weight to run IT equipment or other various equipment. The collapsed ceiling was likely to have been due to a culmination of events over time and not due to any single event.

Photo #1 - Collapsed ceiling in hallway

In order to prevent localized ceiling failures, we recommend preventing people from using any suspended ceiling to fully support their weight in any way, as they are not designed to support a person's weight. We recommend repairing all water leaks that leaks onto suspended ceilings and taking preventative measures to ensure water does not get into the suspended ceilings, as this would add weight to the suspended ceilings and could potentially lead to a collapse in the future.

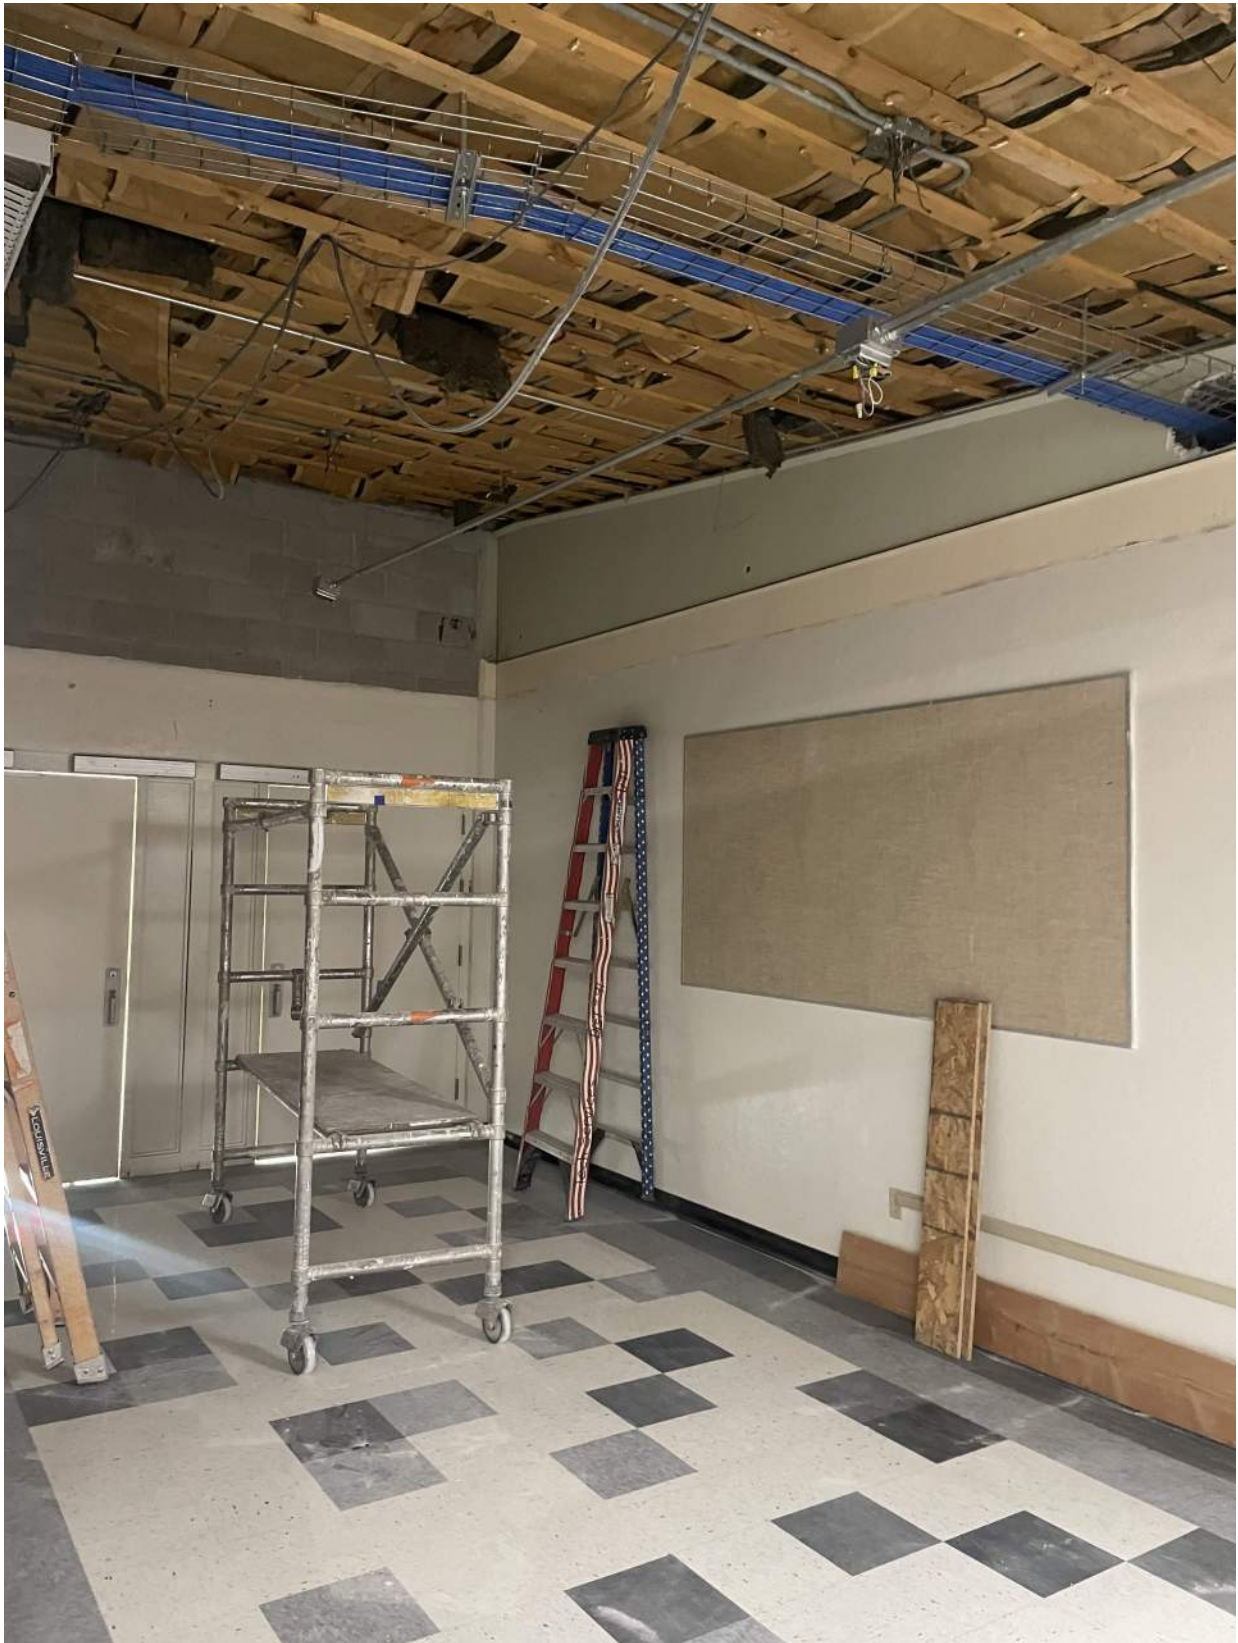
The portion of suspended ceiling that collapsed appears to have had wire ties stapled to the sides of 1x furring strips attached to the underside of the precast concrete roof. The furring strips do not appear to have been affected by the collapse of the acoustical

ceiling. No water damage was observed in the collapsed ceiling. There was observed to be internet cables and other IT equipment run through this area that is believed to have been installed after the ceiling was already installed, see photo #2. The superintendent made the observation that there was a plank run across the collapsed area that was potentially used for walking across the suspended ceiling to install various equipment.

Photo #2 - Area where ceiling collapsed, after removal

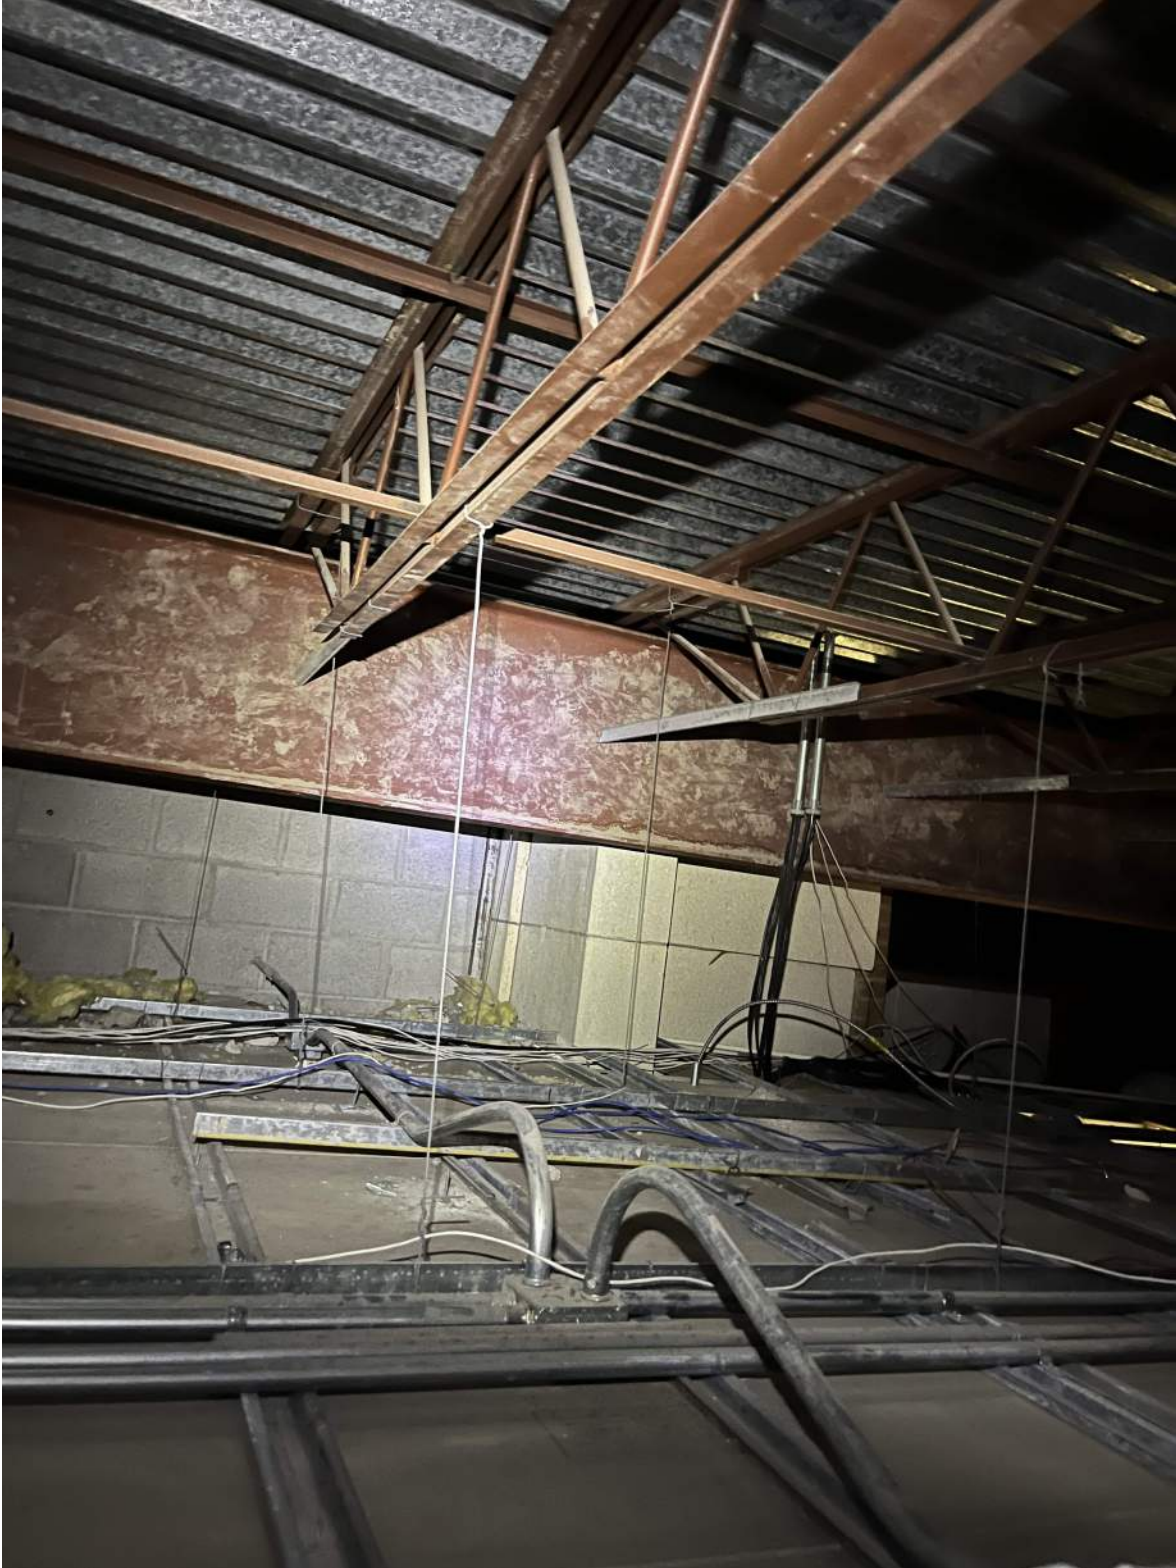
Photo #3 - Support of 1st floor suspended ceiling in 1991 addition

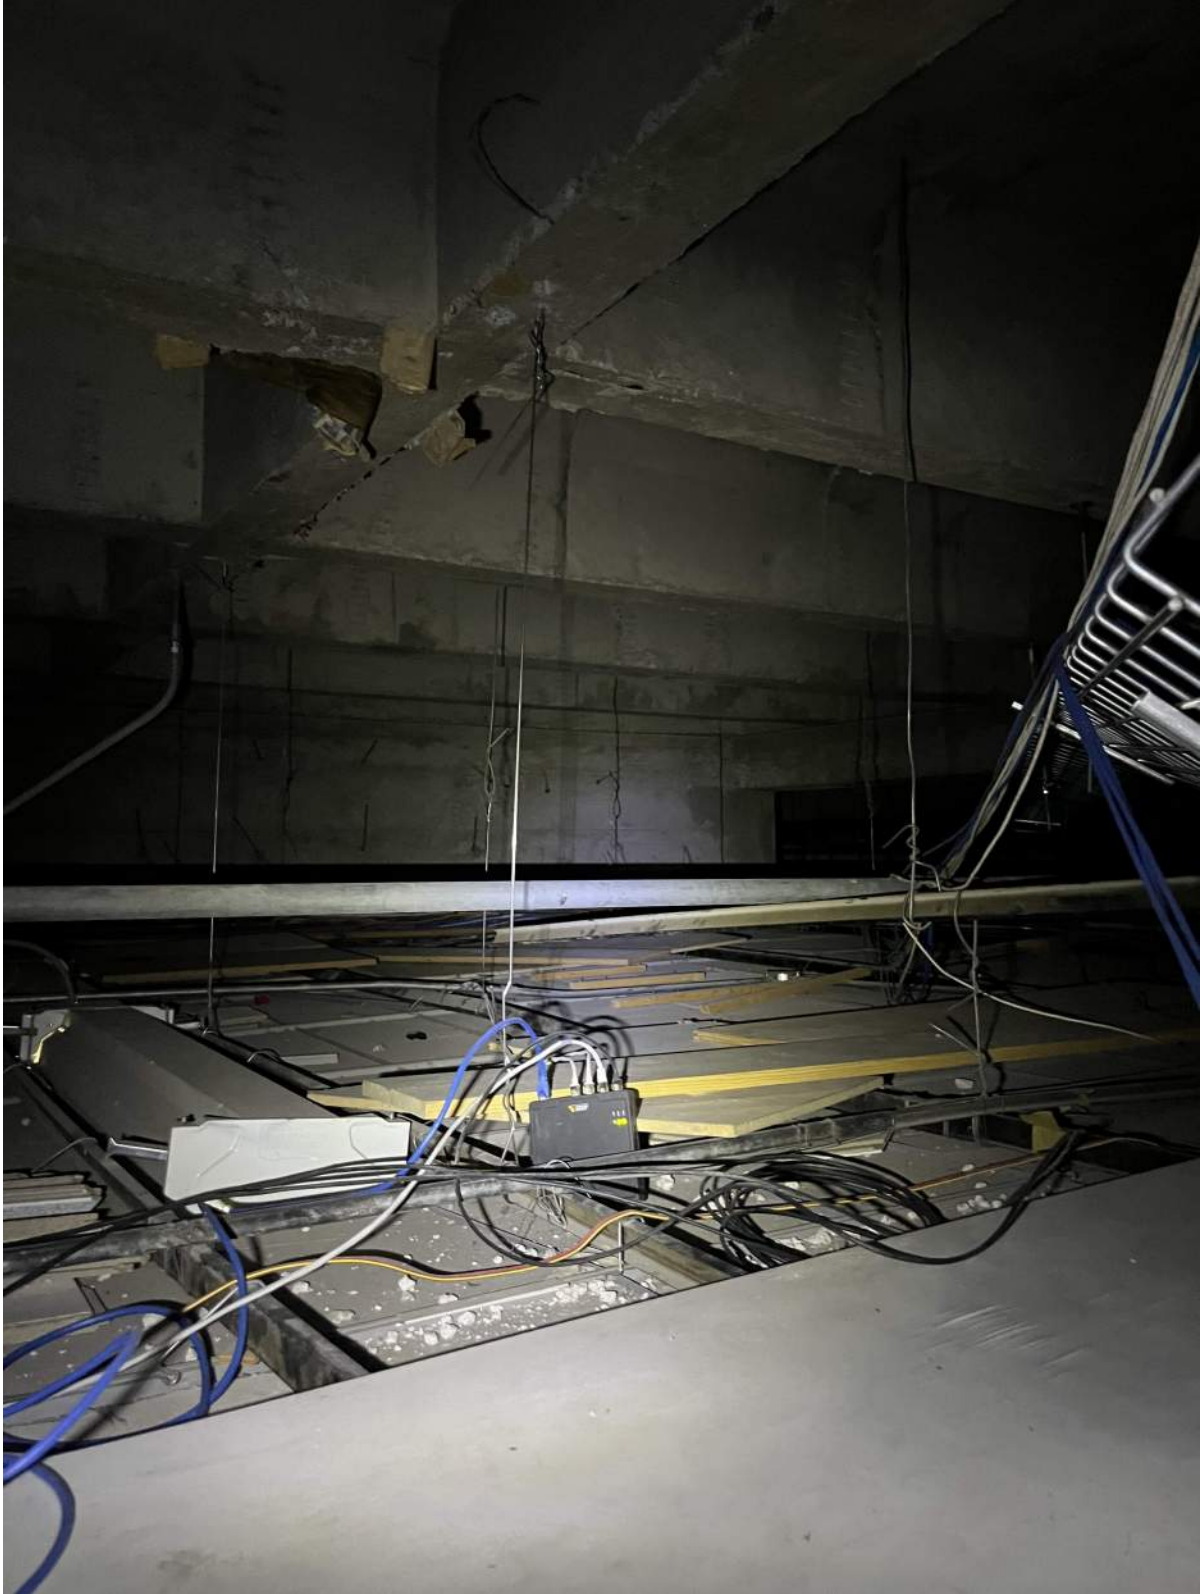
Photo #4 - Support of 1st floor suspended ceiling in section of original building

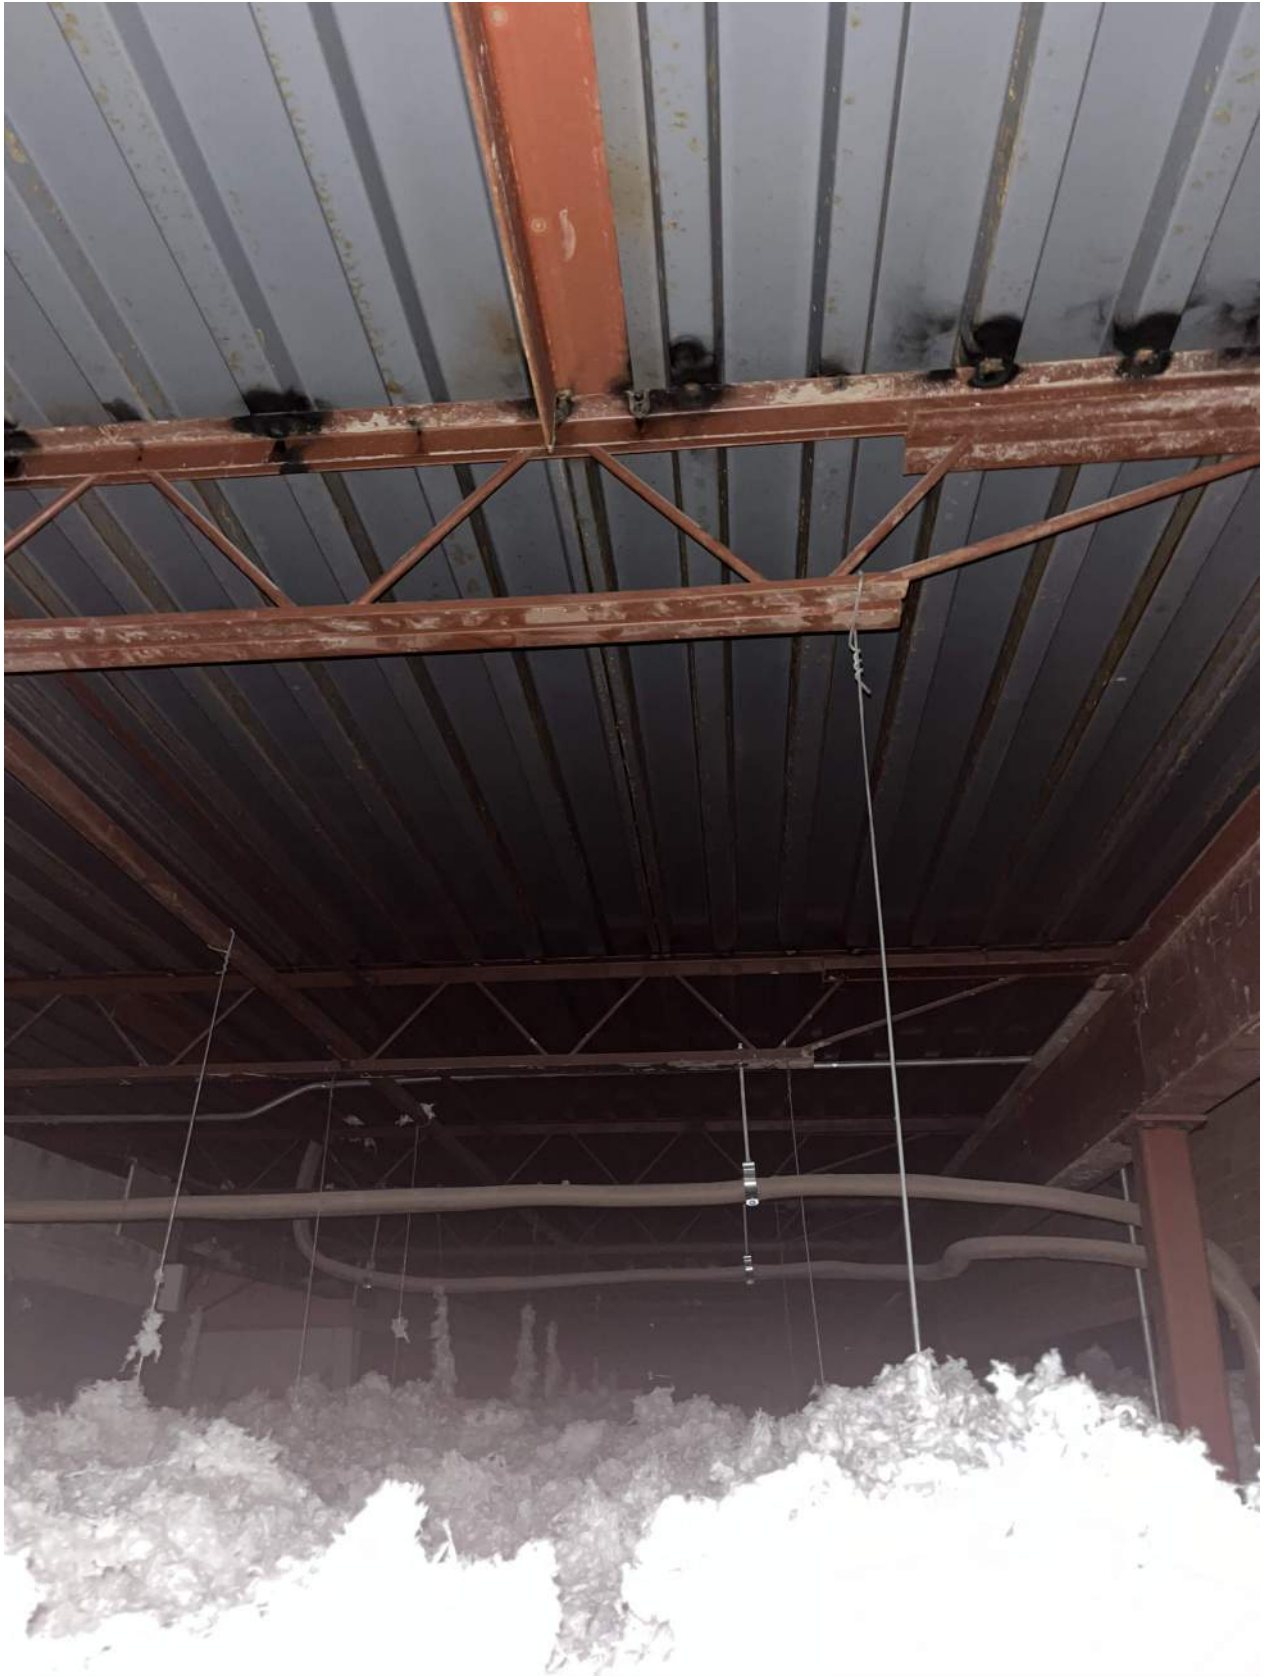
The suspended ceiling appears to be peel and stick acoustical tiles adhered to a single layer of gypboard and suspended from the roof or floor framing with wire ties at an unknown spacing pattern. The suspended ceiling that collapsed appears to have been supported by wire ties that were stapled to a 1x furring strip that was anchored to the underside of the precast concrete roof. It is unknown how the furring strips were attached to the concrete. The suspended ceiling on the second floor of the 1991 addition appears to have the wire ties wrap around the steel joists and attach to a frame for the acoustical tiles, see photo #5. The suspended ceiling on the first floor of a portion of the original building appears to have the wire ties anchored on top of the precast concrete and protrude through the precast concrete to support the ceiling frame, see photo #4. The suspended ceiling on the 1st floor of the 1991 addition appears to have the wire ties wrap around the steel joists and attach to a frame for the acoustical tiles, see photo #1. There was slight water damage observed to small areas of acoustical tiles on the second floor. There was blown in insulation observed resting on the suspended ceiling on the second floor, see photo #5.

Photo #5 - Support of suspended ceiling on second floor in 1991 addition
